# MAGNITUDE 7.8 EARTHQUAKE

Saranggani and Davao Occidental

## PHASE 2: REBUILDING

Restoring our church. Restoring hope.

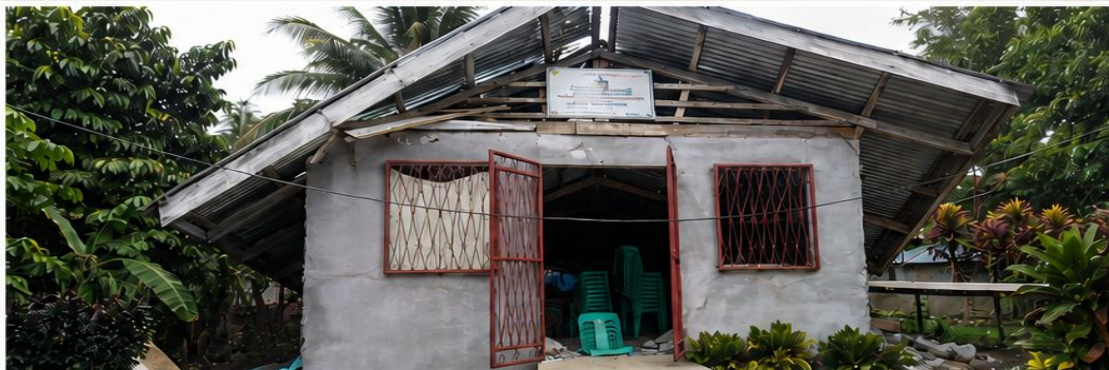
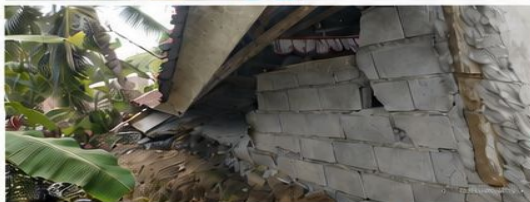
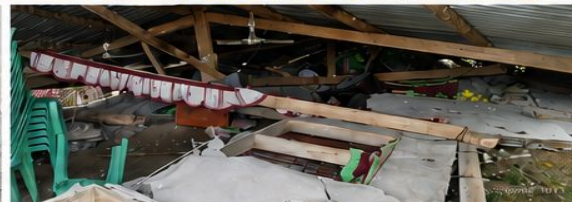
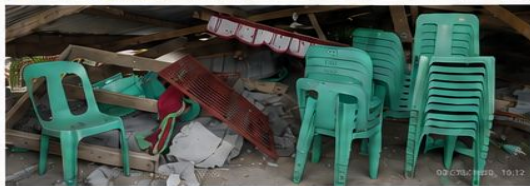
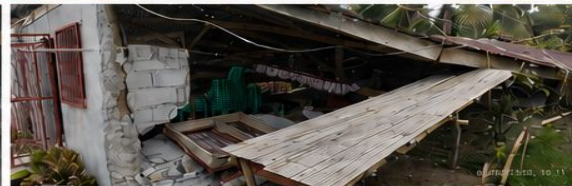
## CROSSING TAGAYTAY CBAP CHURCH

**TOTAL COLLAPSE**

Crossing Tagaytay CBAP Church sustained one of the most devastating levels of damage among the affected churches in the earthquake. The collapse of its foundation, walls, and roof has rendered the structure beyond repair, requiring a complete rebuilding effort.

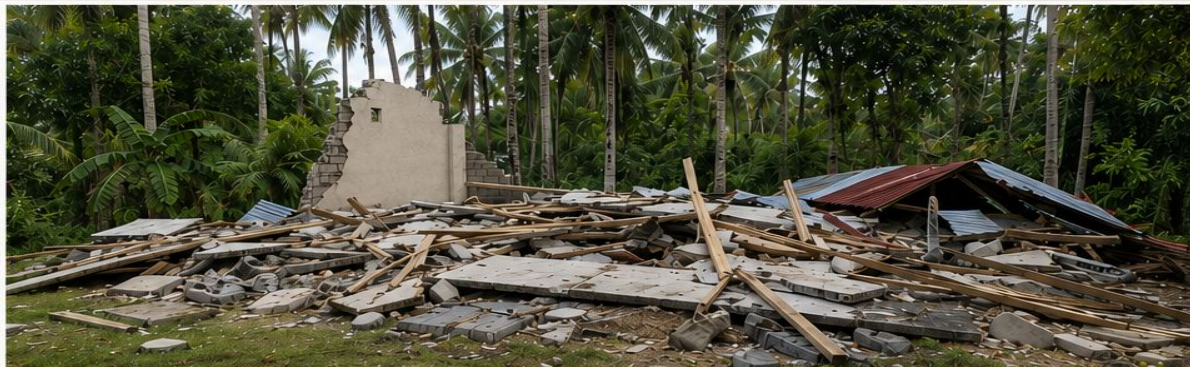
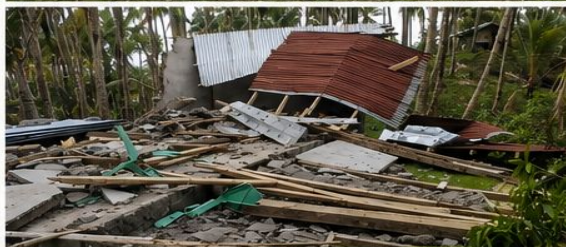
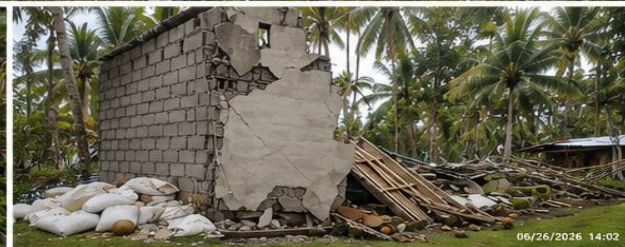
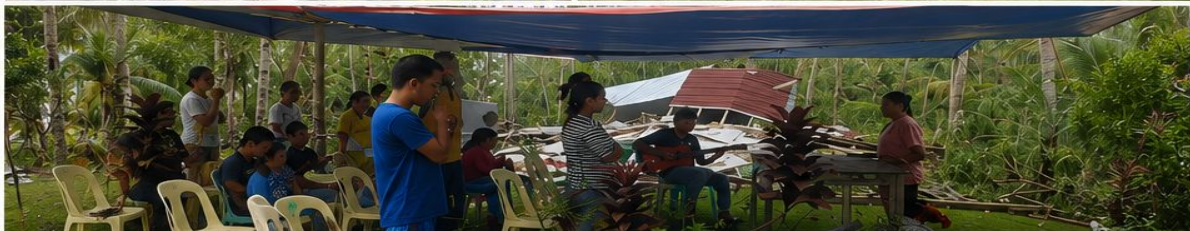
## KILAYA CBAP CHURCH

**TOTAL COLLAPSE**

Kilaya CBAP Church sustained total destruction during the Magnitude 7.8 earthquake that struck Davao Occidental and Sarangani in June 2026. The violent ground shaking caused the complete collapse of the sanctuary, leaving only portions of a masonry wall standing while the remainder of the structure crumbled into rubble.

The church is no longer safe for occupancy and requires complete reconstruction.

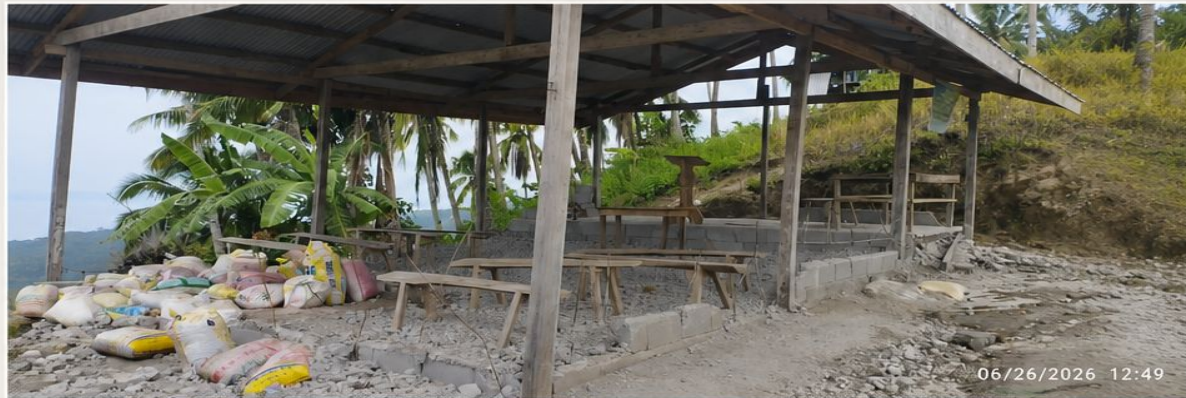
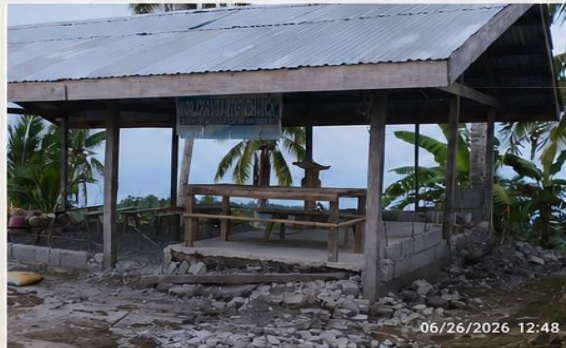
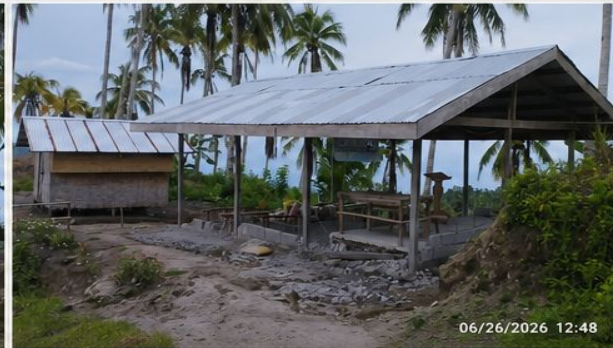
## KAPLOBAY BAPTIST CHURCH

**PARTIAL MAJOR**

Kaplobay Baptist Church sustained partial major damage during the 7.8 magnitude earthquake. The structure experienced significant damage to its foundation, pillars, and walls. Debris and structural displacement were observed in several areas.

While the building is still partially standing and may be used with caution for the meantime, extensive repairs and strengthening are needed to ensure the safety of the congregation.

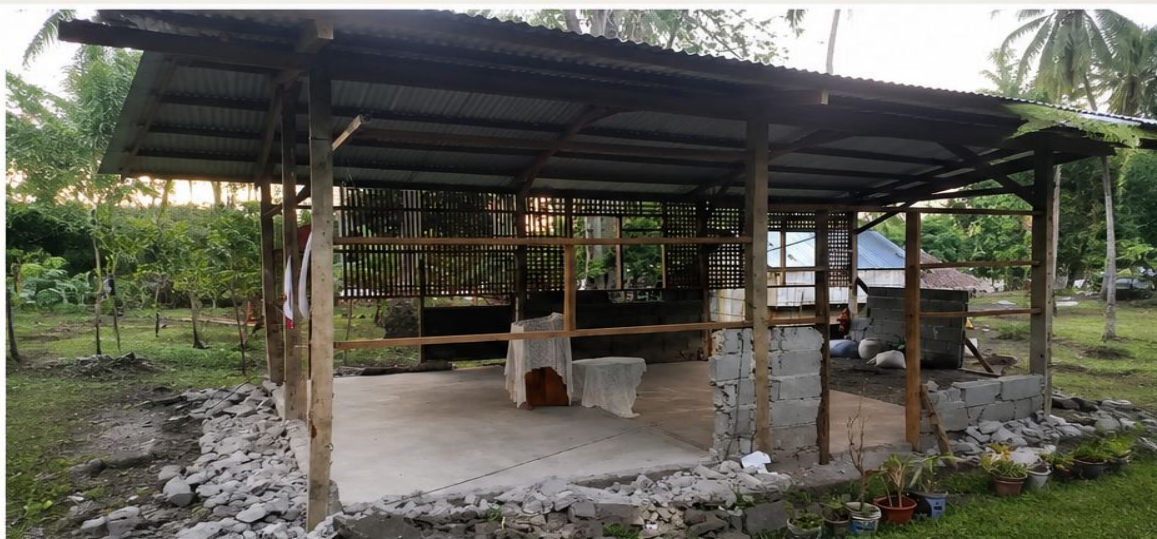
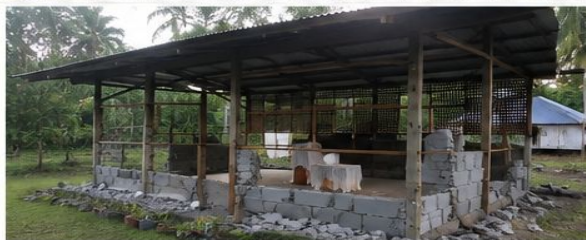
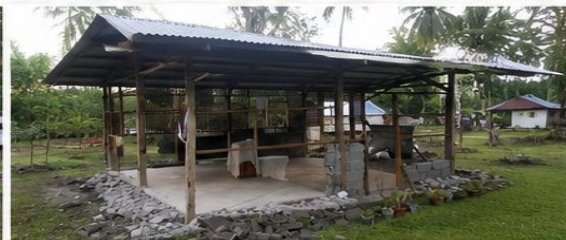
## KALBAY TLV CHURCH

**MAJOR PARTIAL**

Kalbay TLV Church sustained major partial damage during the 7.8 magnitude earthquake. The structure suffered significant damage to its walls, pillars, and foundations. Several concrete blocks collapsed, and portions of the building are unsafe for full use.

While part of the church is still standing and can be used with caution, urgent repairs and structural reinforcement are needed to ensure the safety of the congregation and continue ministry effectively.

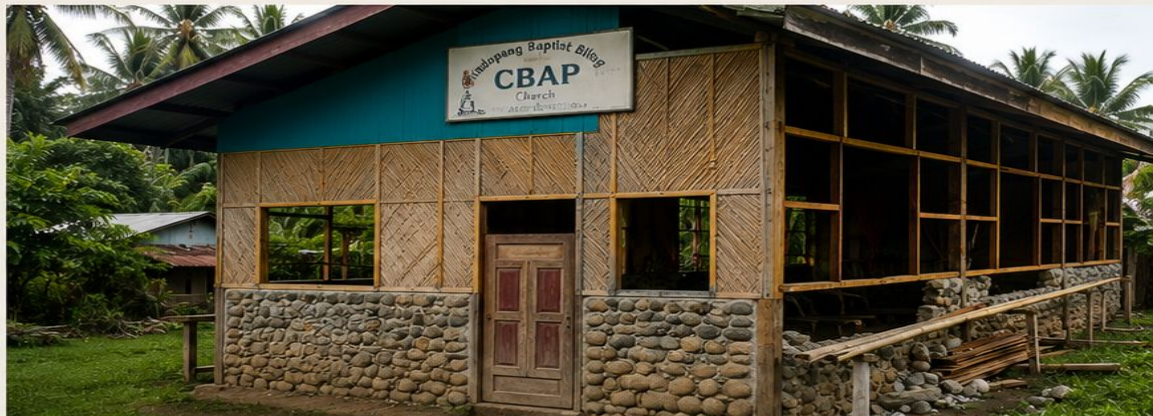
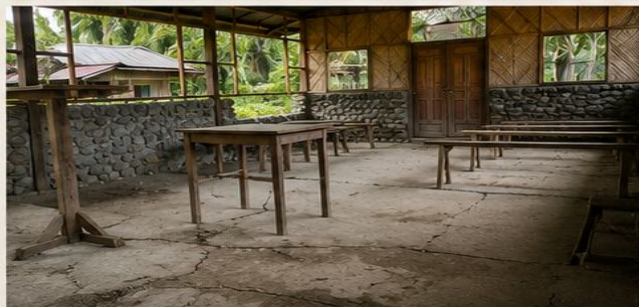
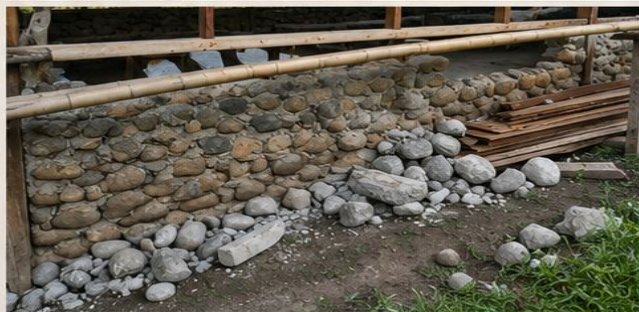
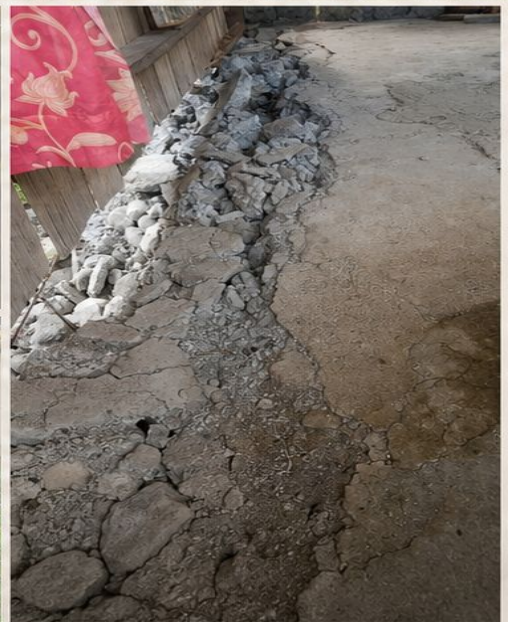
## KADUPANG CBAP CHURCH

**PARTIAL MAJOR DAMAGE**

Kadupang CBAP Church sustained partial major structural damage during the Magnitude 7.8 earthquake that struck Southern Mindanao on June 8, 2026. While the timber superstructure and roofing system largely remained standing, the earthquake caused severe failure of the stone masonry foundation, extensive cracking of the concrete flooring, and displacement of structural components supporting the sanctuary.

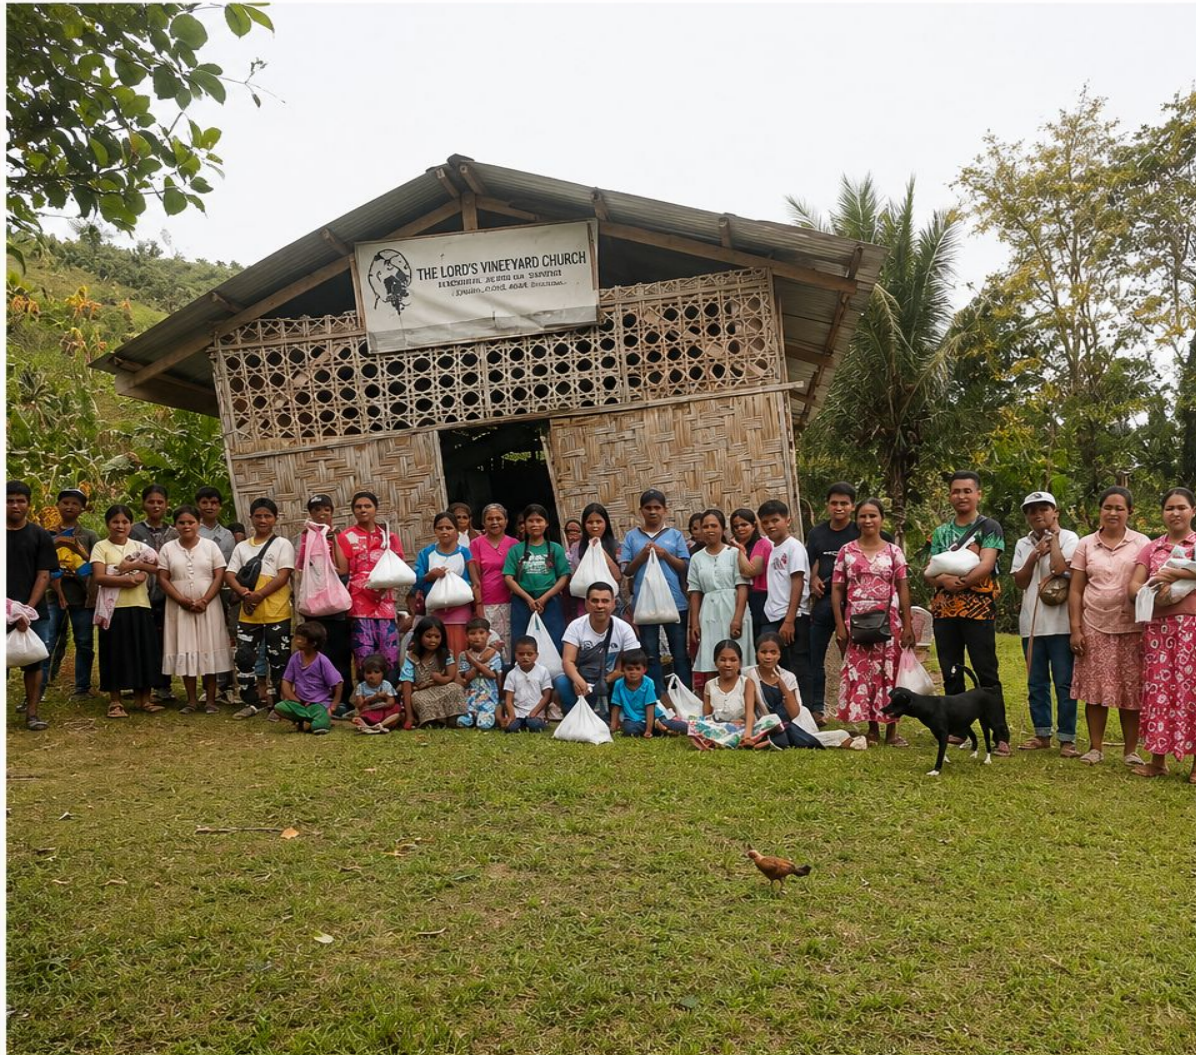
## KIDAMAN TLV CHURCH

**PARTIAL MAJOR DAMAGE**

The church building sustained partial major damage during the Magnitude 7.8 earthquake that struck Southern Mindanao on June 8, 2026. The whole building is leaning to the left, causing structural instability and posing a safety risk to the congregation.

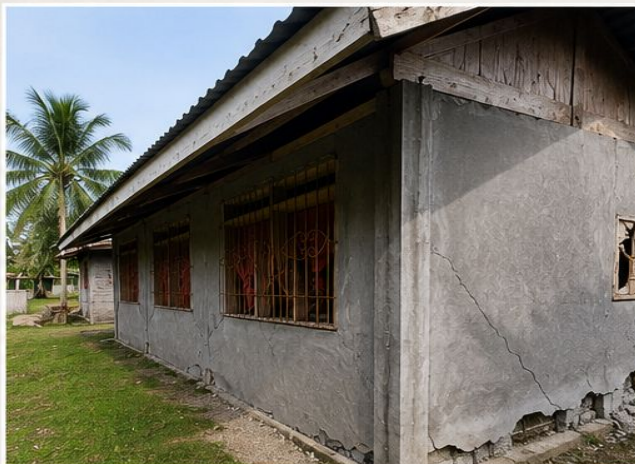
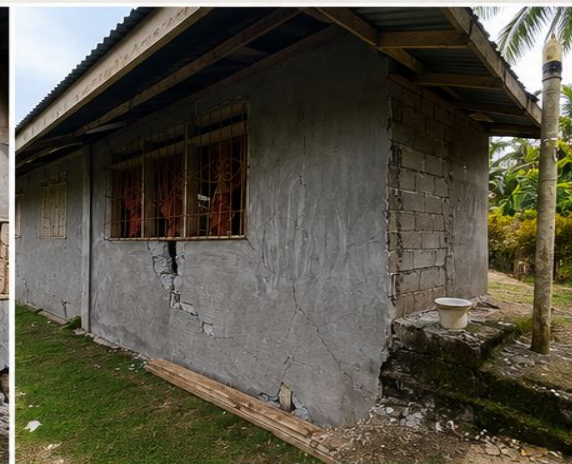
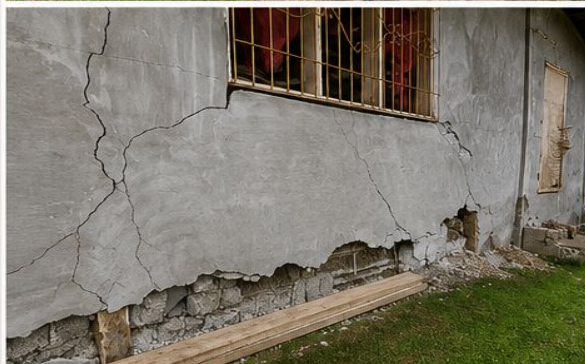
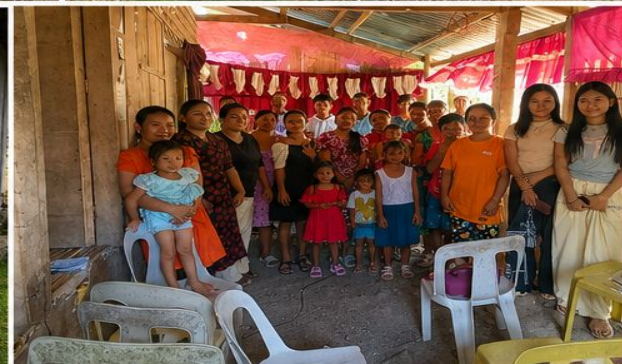
## CROSSING PACO CBAP CHURCH

**PARTIAL MAJOR**

Crossing Paco CBAP Church sustained major partial damage during the Magnitude 7.8 earthquake that affected Sarangani and nearby provinces. The earthquake caused extensive cracking of the reinforced concrete walls, separation of masonry from the structural frame, and damage to the foundation and exterior walls. Although the roof remains largely intact, the structural integrity of the sanctuary has been compromised, making continued occupancy unsafe without substantial repairs.

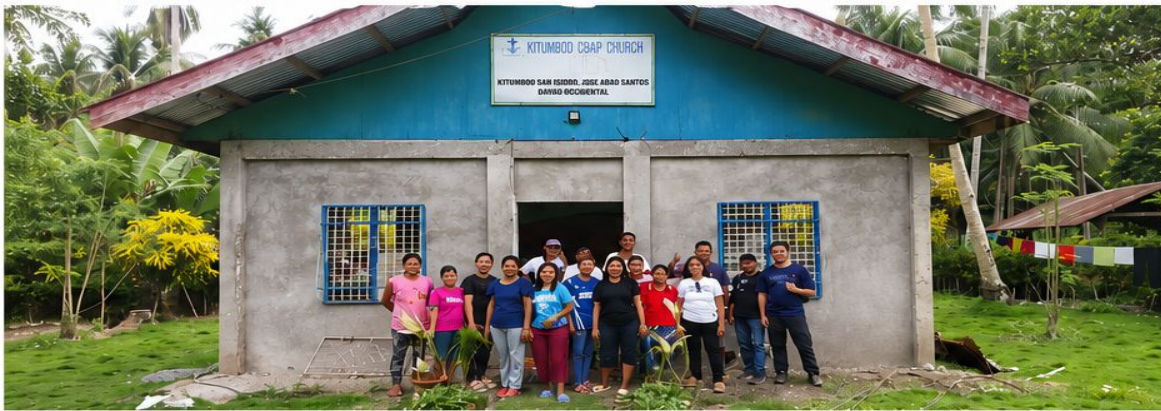
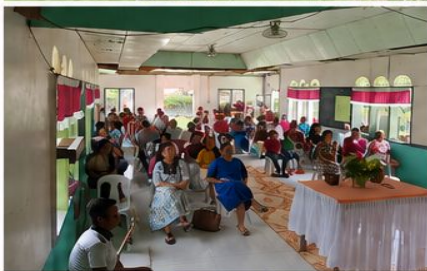
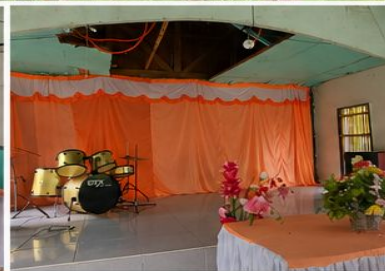
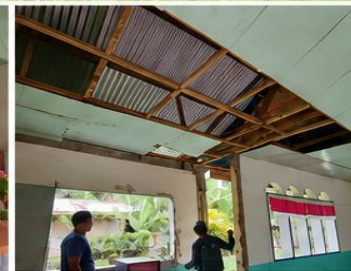
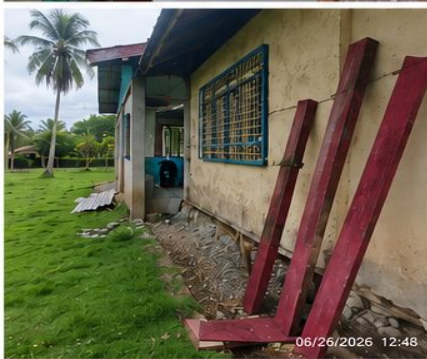
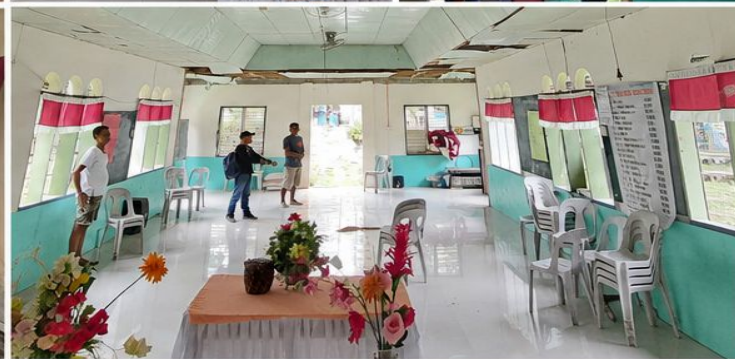
## KITUMBOD CBAP CHURCH

**MAJOR PARTIAL DAMAGE**

Kitumbod CBAP Church sustained major partial damage during the 7.8 magnitude earthquake. The structure experienced significant damage to its ceilings, walls, roof, and supporting posts.

While the building is still partially standing and is currently being used for services, repairs and strengthening are essential to ensure the safety and continued ministry of the congregation.

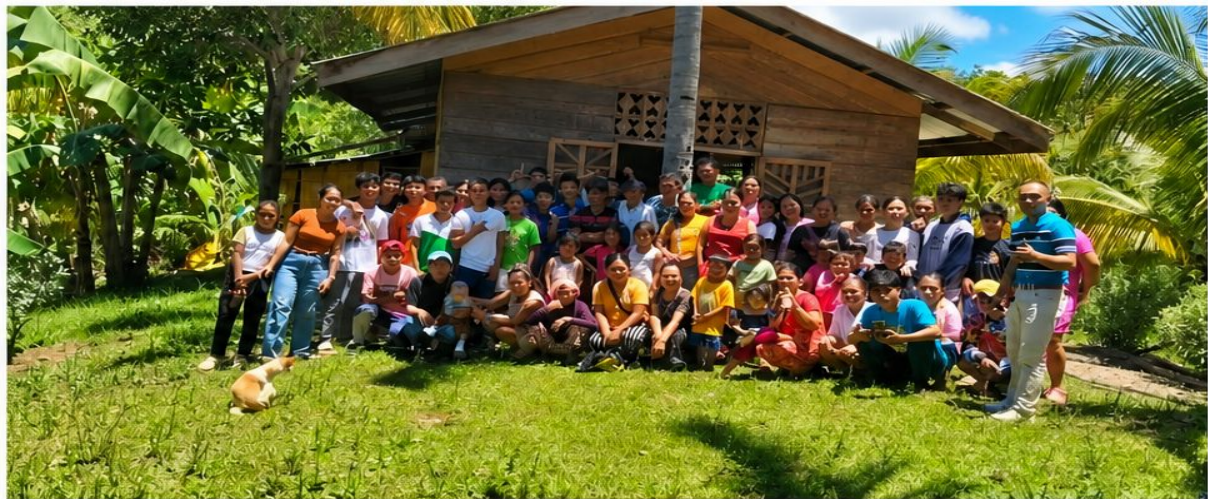
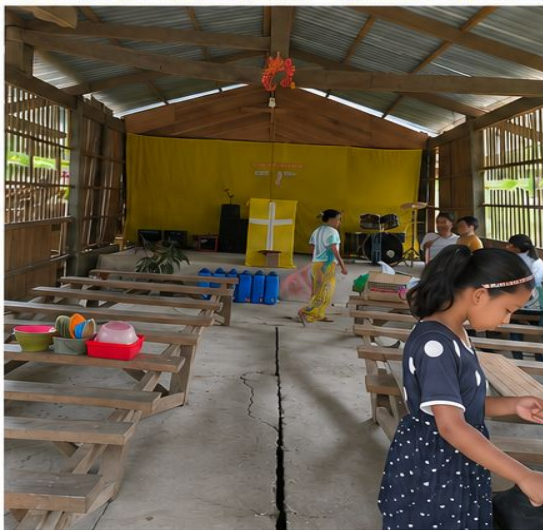
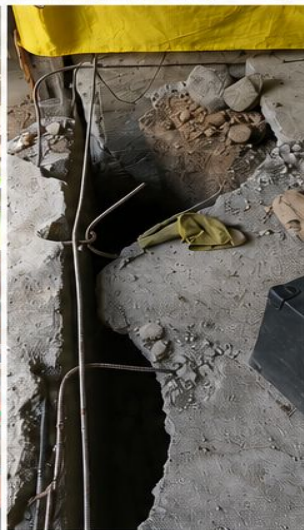
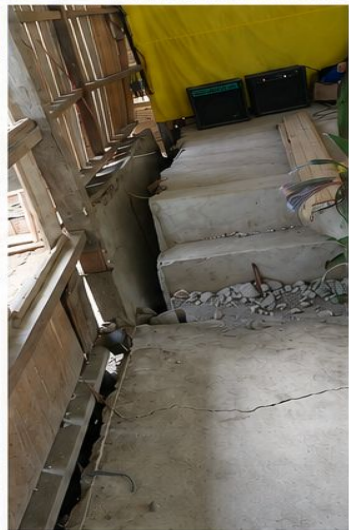
## AKBAANG CBAP CHURCH

**PARTIAL MAJOR DAMAGE**

Akbaang CBAP Church sustained partial major damage during the Magnitude 7.8 earthquake that struck Southern Mindanao on June 8, 2026. The whole building is leaning to the left, causing structural instability and posing a safety risk to the congregation. Cracks were observed on the foundation and flooring. Immediate repair and stabilization are needed to prevent further damage and ensure the safety of the congregation.

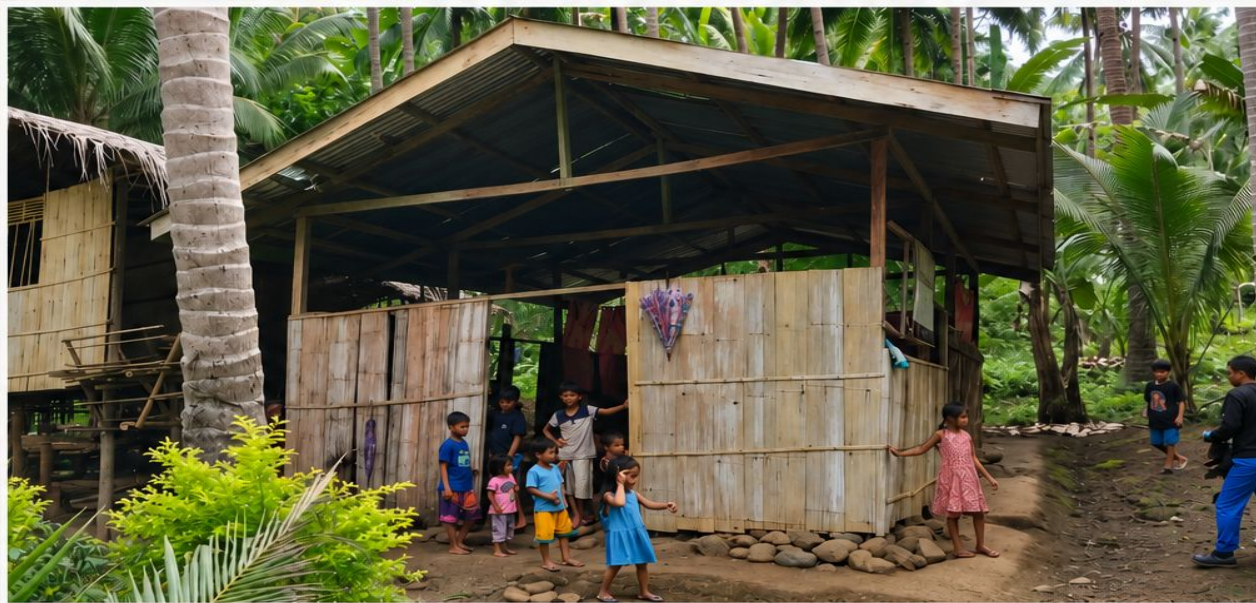
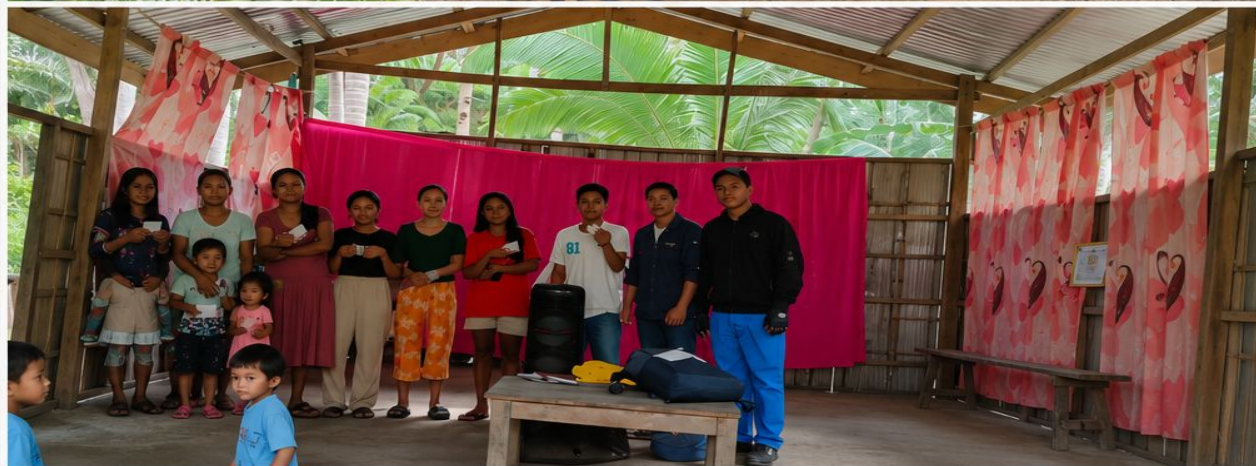
## MAYBIO KIANAW CHURCH

**WHOLE STRUCTURE IS LEANING**

Maybio Kianaw Church sustained severe damage during the Magnitude 7.8 earthquake that struck Southern Mindanao on June 8, 2026. The whole structure is leaning to one side, showing signs of foundation failure and instability. Immediate attention is needed to ensure the safety of the congregation and prevent further collapse.

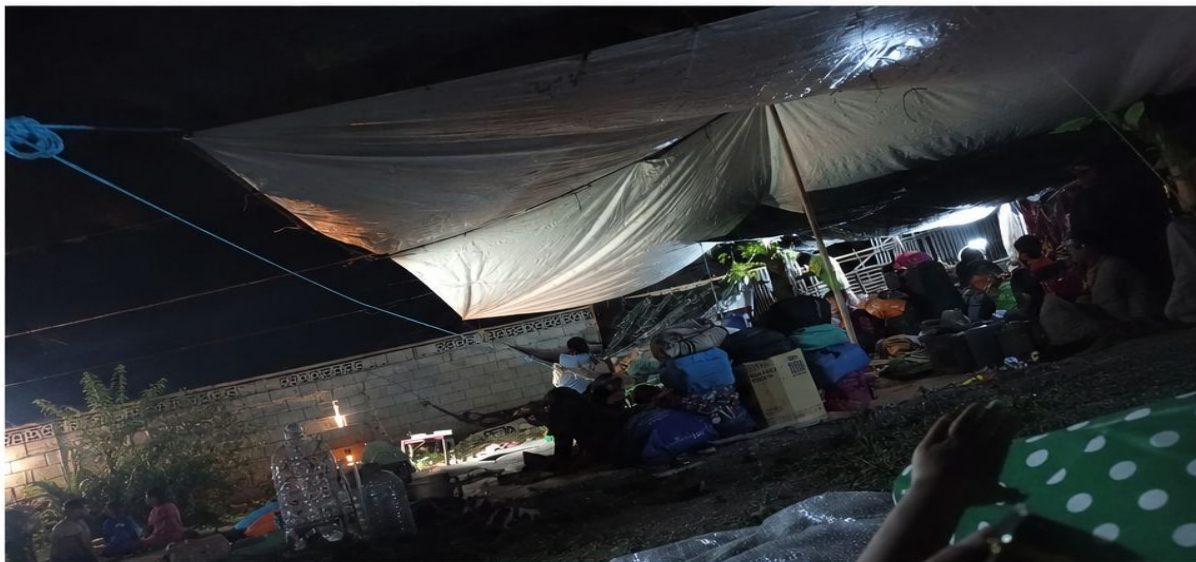
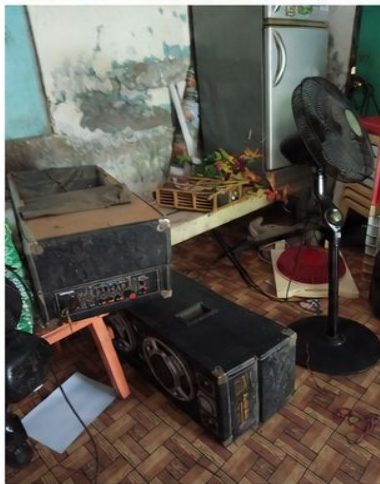
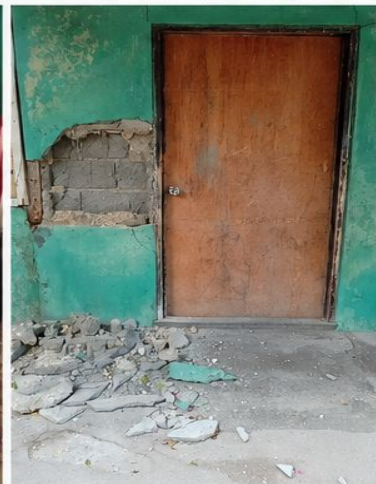
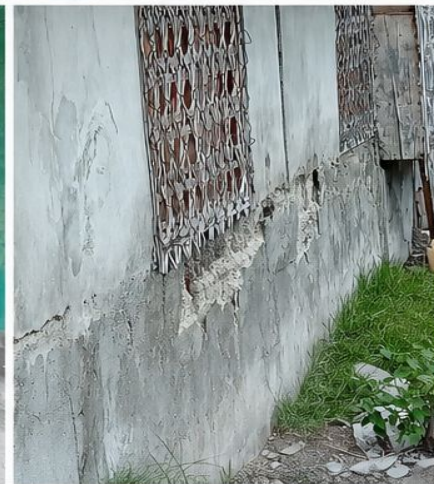
**MISSION CENTER:**  
**KALINAW SA BAGONG PAG-ASA CENTER**

**DAMAGE CLASSIFICATION:**  
**MINOR DAMAGE**

Kalinaw sa Bagong Pag-Asa Center sustained minor damage during the Magnitude 7.8 earthquake that struck Southern Mindanao on June 8, 2026. The building experienced some structural cracks and falling debris, but remains safe for continued use and ministry.
